Carsins Runs I-95 Section 200 Stream Mitigation

PS&E Design Report

Prepared for
MDTA

Carsins Run Stream Mitigation Existing Conditions Site Photographs

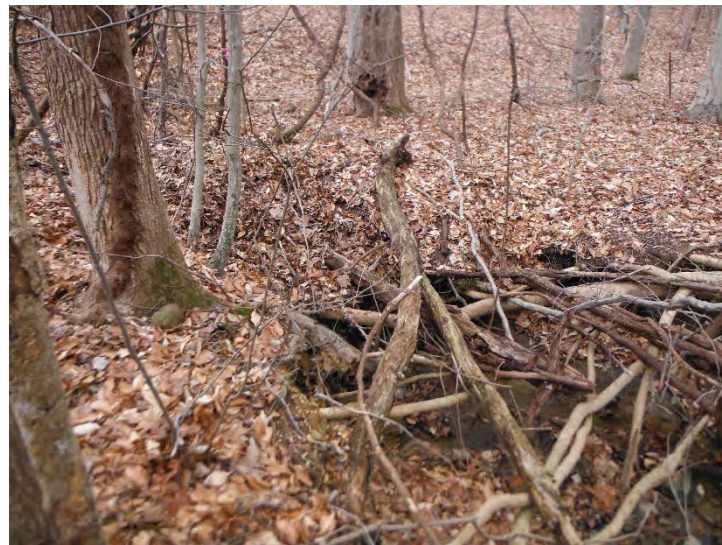
Facing upstream at knick point on northwest tributary fork near confluence with mainstem.

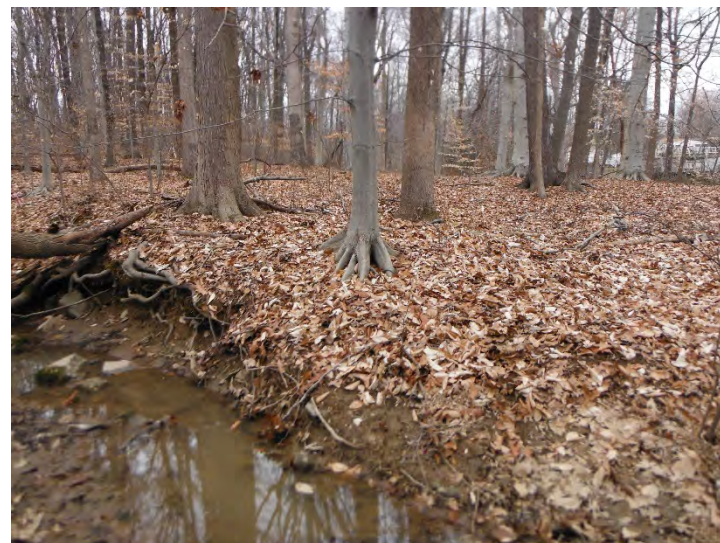
Facing upstream at buttress trees in left floodplain from Sta. 7+75.

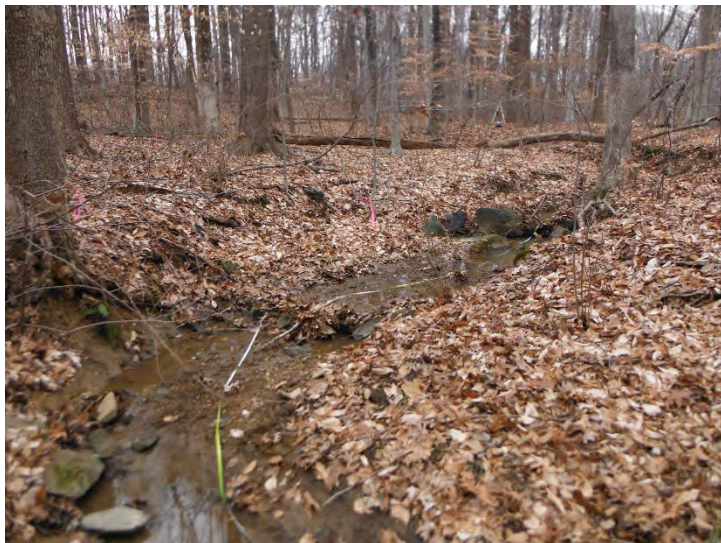
Facing upstream from station 7+75. Photo shows alternating point bars, right bank erosion, and boulder knick point.

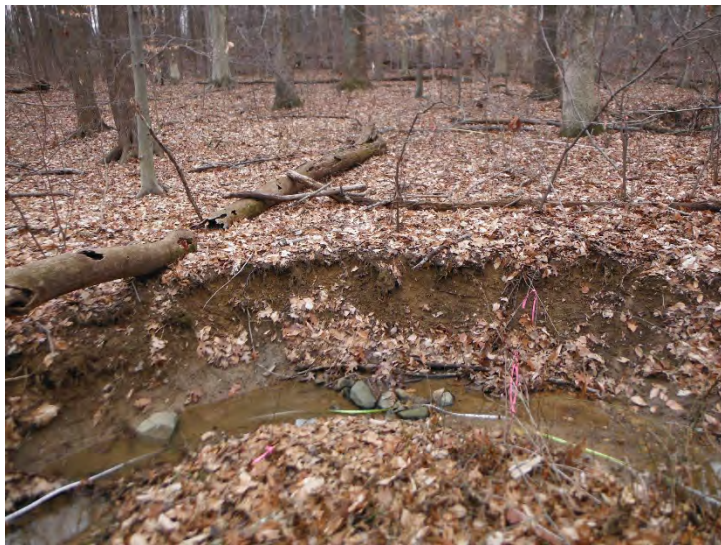
Facing right bank at typical outer bend bank erosion in Reach 3 (from Sta. 6+30)

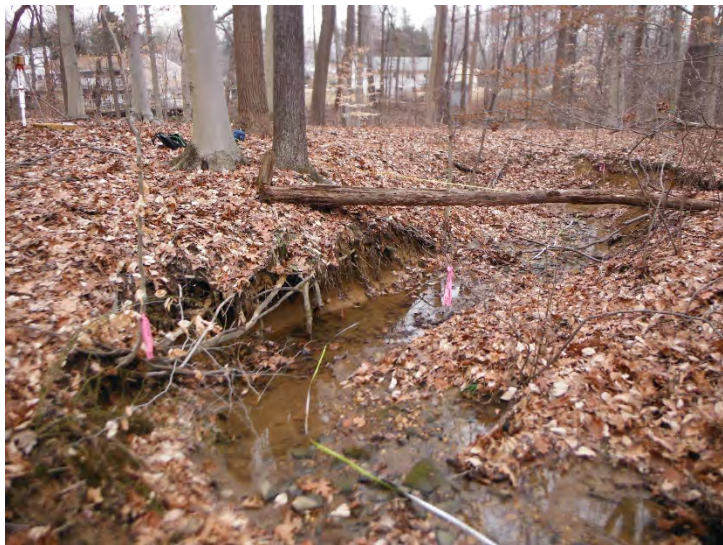
Facing downstream at undercut bank just upstream of surveyed cross section.

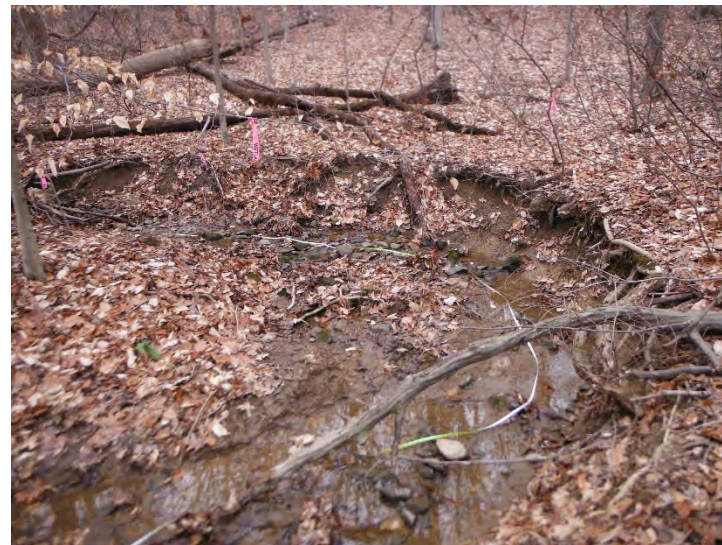
Facing upstream from near 5+50 at typical bank erosion.

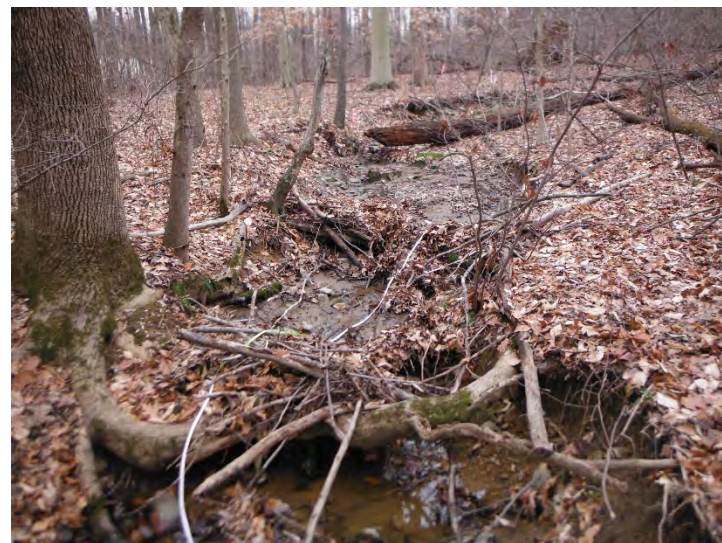
Facing upstream at 2 foot knick point between Reaches 2 & 3.

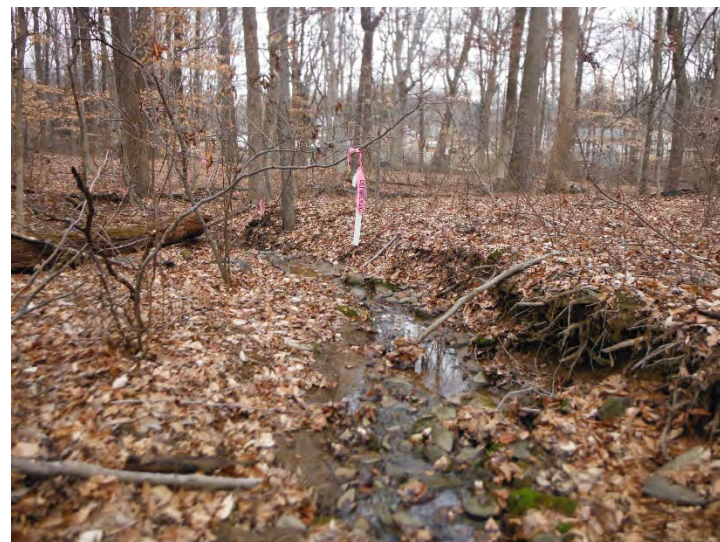
Facing downstream at the downstream end of the Reach 2b step pools where there is minor right bank erosion.

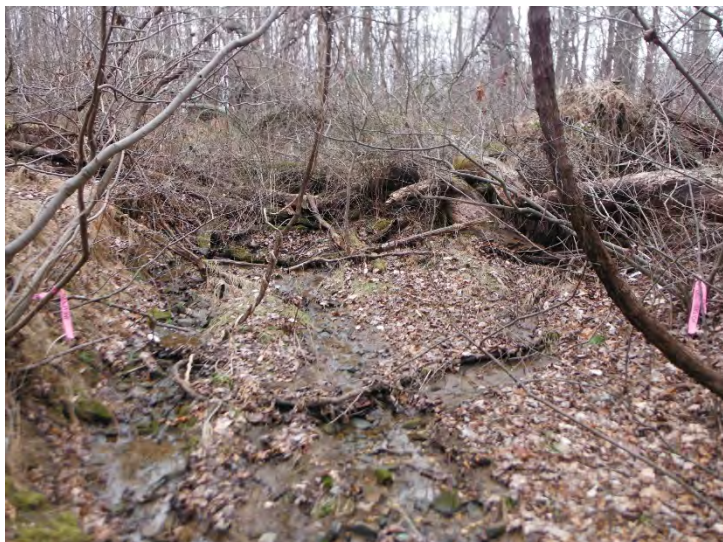
Facing upstream at debris jam / knick point (break between Reach 1&2)

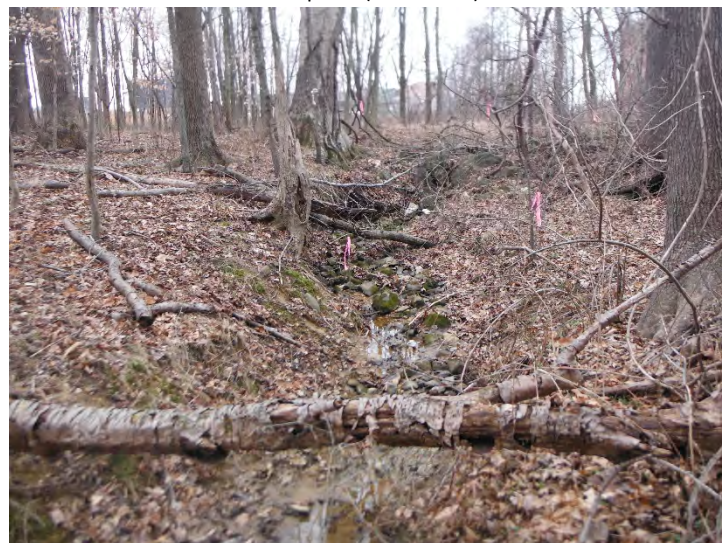
Facing upstream at upstream most knick point (~Sta. 0+25)

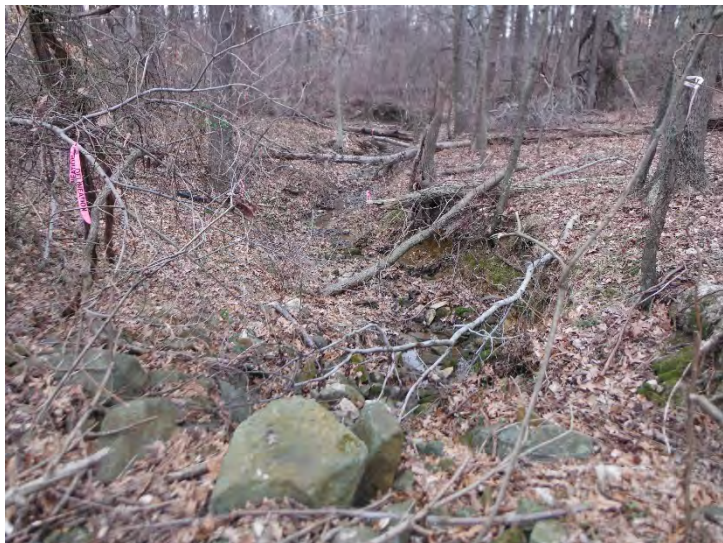
Facing downstream at upstream most knick point (~Sta. 0+25)

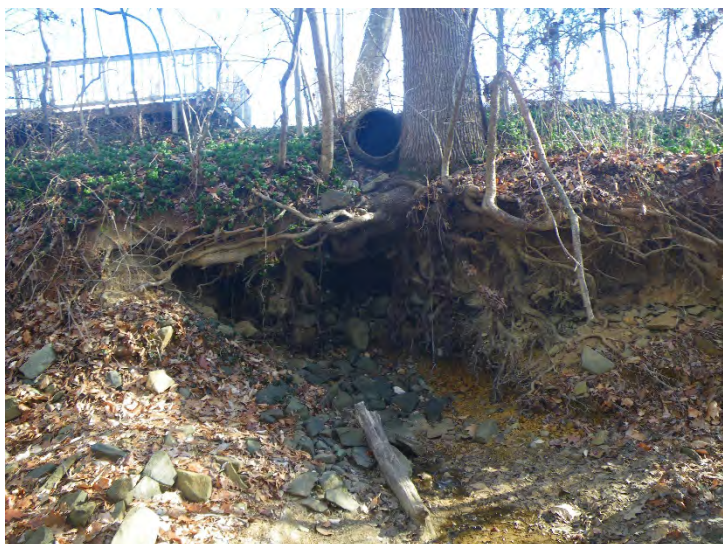
The upstream extent of the Mainstem Reach is just upstream of the Randolph Drive cul-de-sac. Here, a deteriorated 21” stormdrain pipe with large sinkholes discharges on the left bank causing significant scour and bank erosion (see Appendix A, page 14). There is a patch of bamboo on the left terrace behind a residence upstream of the stormdrain pipe.

Facing left bank at severe erosion at 21" stormdrain outfall off of Randolph.

- Improve habitat and water chemistry by removing concrete and introducing riffle grade control and w-weir structures.
- Improve public safety by replacing failed 21” stormdrain at Randolph Drive and introducing a drop structure.
- Improve bank stability and reduce potential sediment from bank erosion by replacing failed 21” stormdrain, addressing the unstable tributary inflows, and installing native plants along portions of the stream banks.

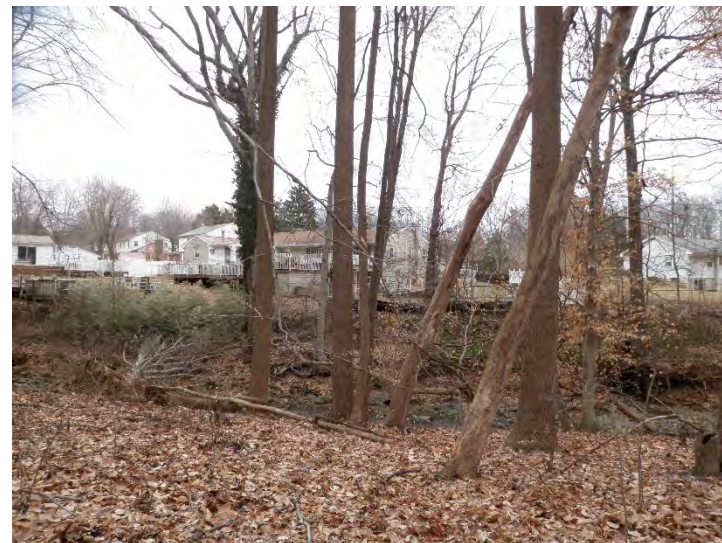
Facing left bank from right terrace (note bamboo stand on left bank upstream of stormdrain outfall).

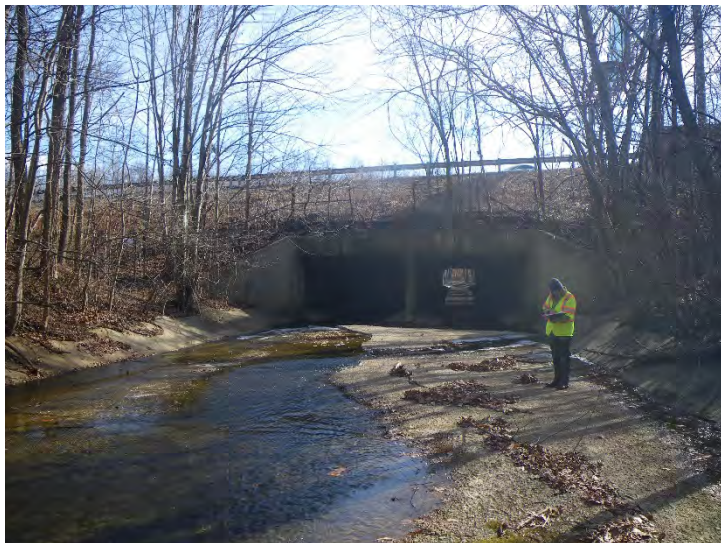
Facing downstream at upstream face of I-95 culvert and concrete lined channel (proposed W-Weir location)

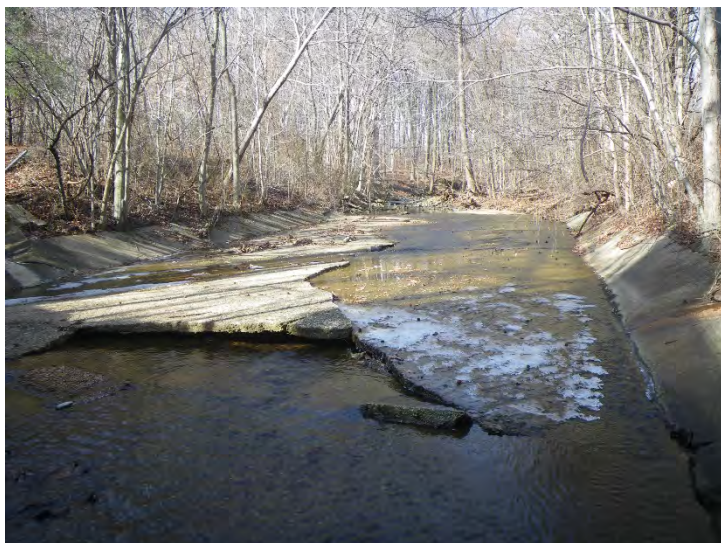
The survey indicates presence of more than 4,000 square feet of concrete-lined bed and banks. However, the observed depositional features (i.e. point bar) suggest that the concrete could extend beyond the area surveyed. KCI obtained the December 10, 1963 as-builts for the Northeastern Expressway (File H-X856C.pdf, contract No. NE 106). The plans indicate that Carsins Run was relocated upstream of I-95. The as-builts indicate 185 linear feet of channel restoration and 200 linear feet ‘stream bed paving’ (width 31 feet). Based on field measurements of observable

concrete, the depth is approximately 3 to 5 inches. It is assumed that the streambed paving is the concrete lined portion of channel. Based on the plan dimensions and field observations, an estimated 80 cubic yards of concrete lines the bottom of Carsins Run upstream of I-95 within the limits of the proposed work. The as-builts do not depict cross sections to reflect the side slope or bank portions of the concrete lined channel. The roadside concrete ditches (type I and type II) noted on the plans, are not being addressed as part of this mitigation project. No test pitting is being performed under the design contract. Verifying and computing the extents and quantities of concrete will be the responsibility of the Contractor.

Facing upstream from Sta. 14+44 (invert of upstream end I-95 culvert) showing broken concrete lining to be removed.

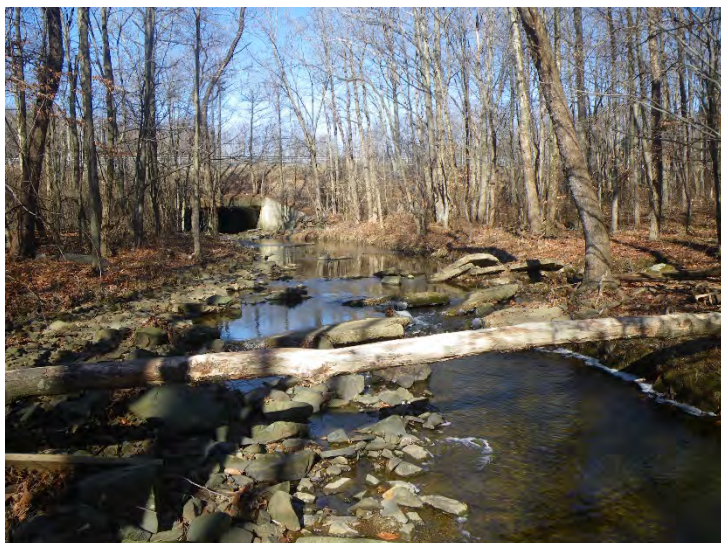
There are various areas where broken slabs of concrete still exist in the channel (see Appendix A, page 16). A number of unstable inflows discharge into the Carsins Run study Reach: the severely eroded outfall from Randolph Drive on the left, the Tributary *forks* on the right, and the roadside drainage ditches adjacent to I-95 upstream and downstream – left and right.

Facing upstream at Carsins Run downstream of I-95 (note broken slabs of concrete).

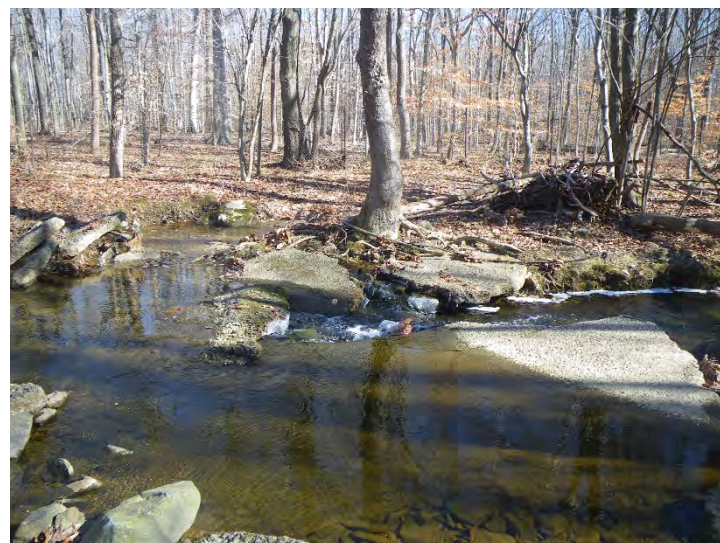
Facing left bank close up of broken concrete slabs.
