Carsins Runs I-95 Section 200 Stream Mitigation

PS&E Design Report

Prepared for
MDTA

Carsins Run Stream Mitigation Existing Conditions Site Photographs

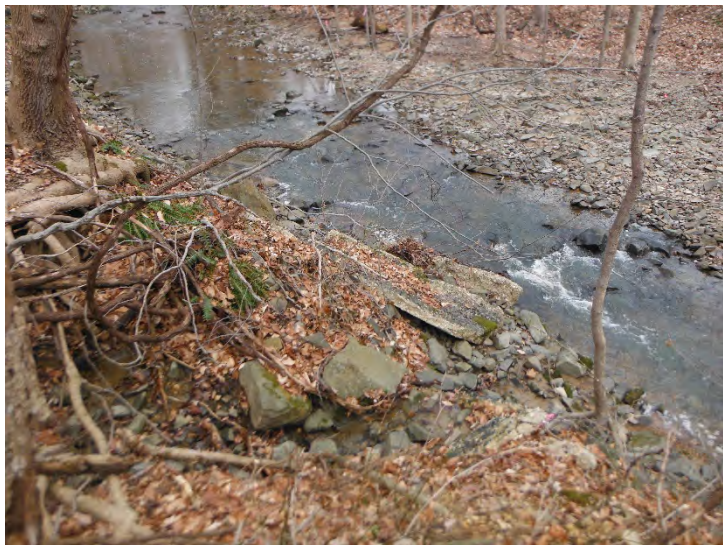
Facing mainstem from top of right bank at upstream confluence of tributary with mainstem.

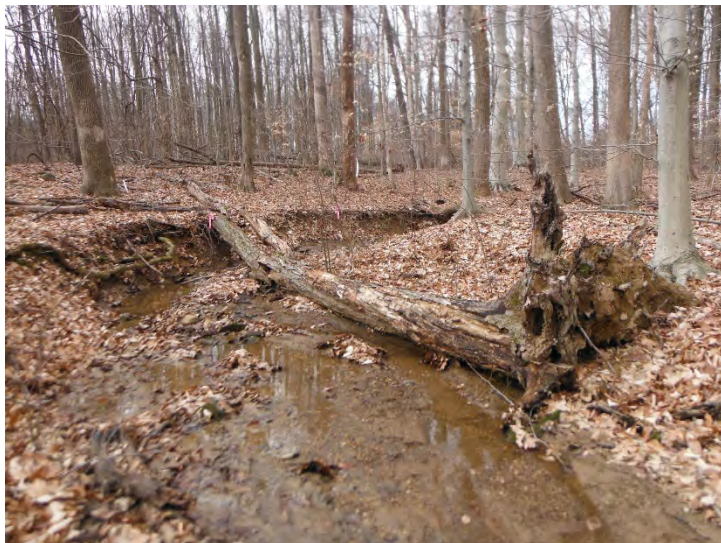
Facing upstream from upstream of tributary fork (~Sta. 8+50).

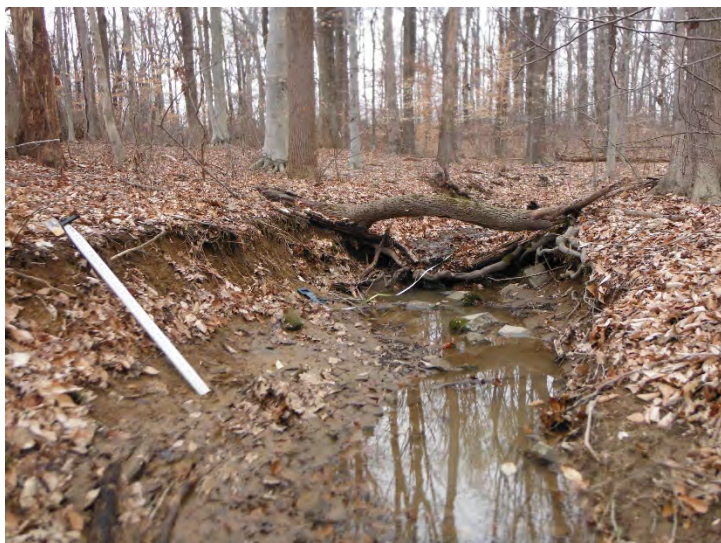
Facing upstream at knick point/headcut. Note, the fines and right bank erosion (~Sta. 7+75).

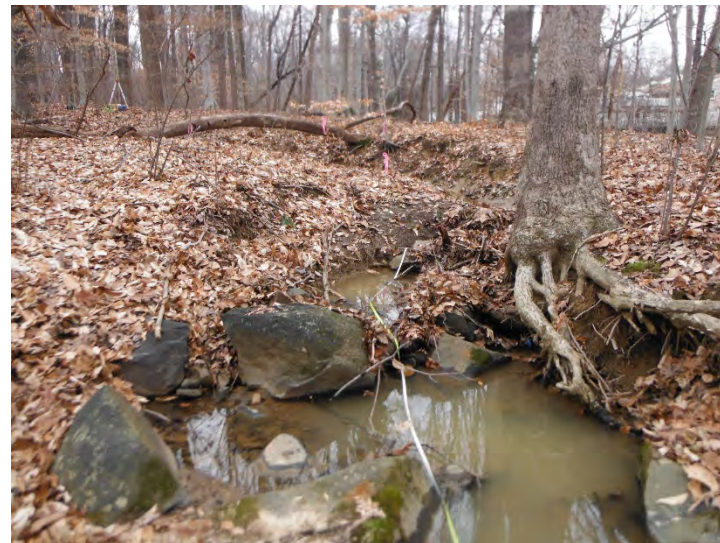
Close-up view upstream at boulder knick point (~Sta. 6+90).

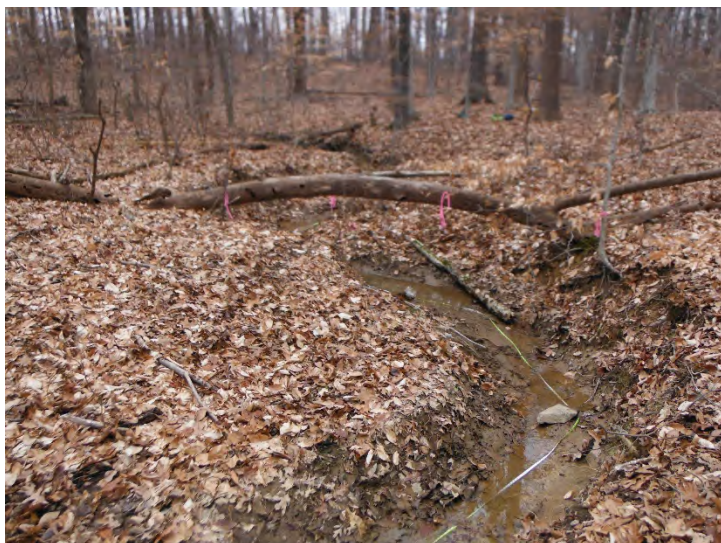
Facing upstream at typical Reach 3 from left floodplain near Sta. 6+65

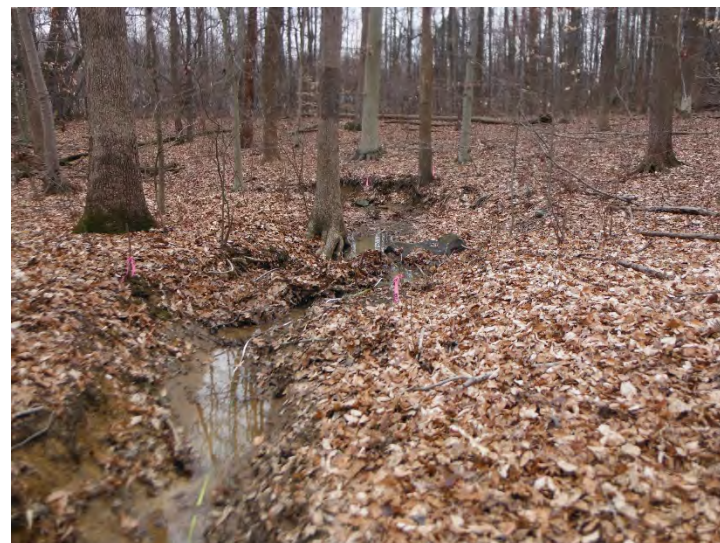
Facing downstream from left floodplain near Sta. 6+50.

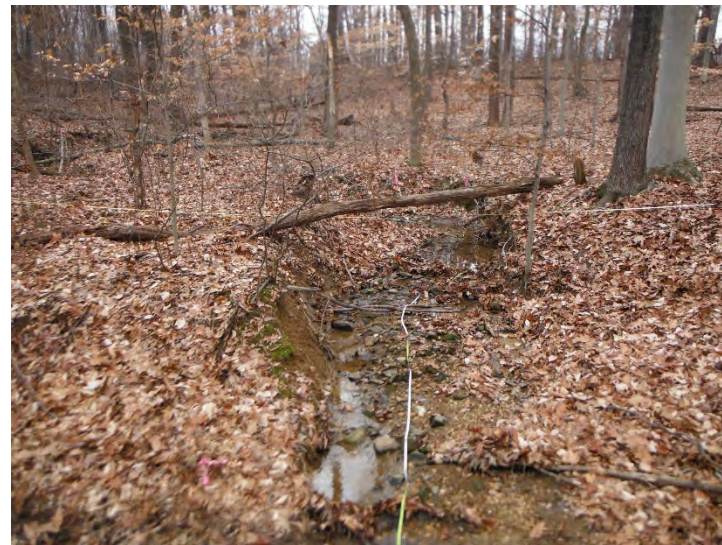
Facing upstream from Sta. 6+30 at surveyed cross section. (point bar feature to the right of the tape in the photo associated with bankfull stage).

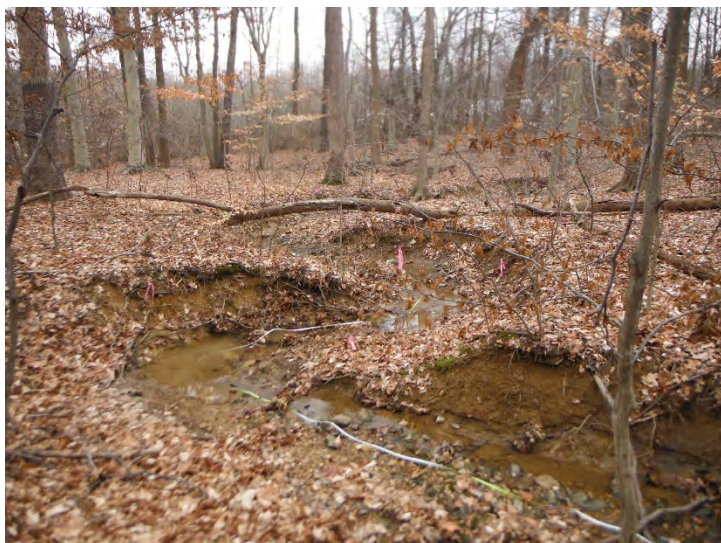
Facing downstream from Sta. 6+20 at typical Reach 3 bank erosion and point bars.

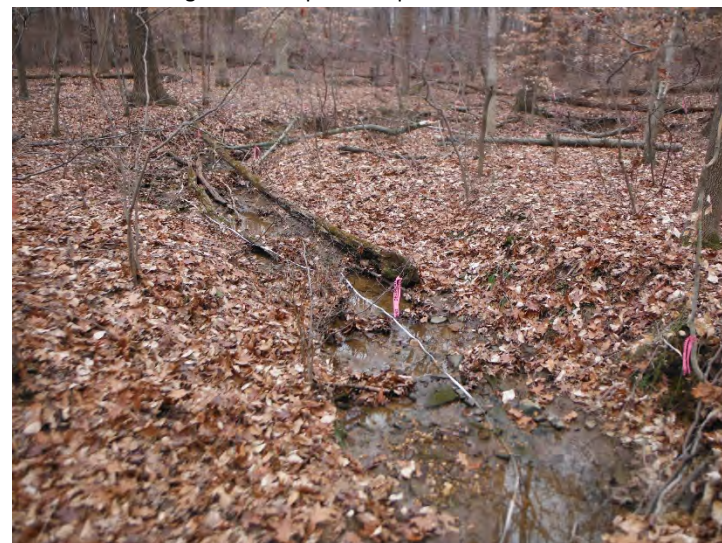
Facing upstream from Sta. 6+10

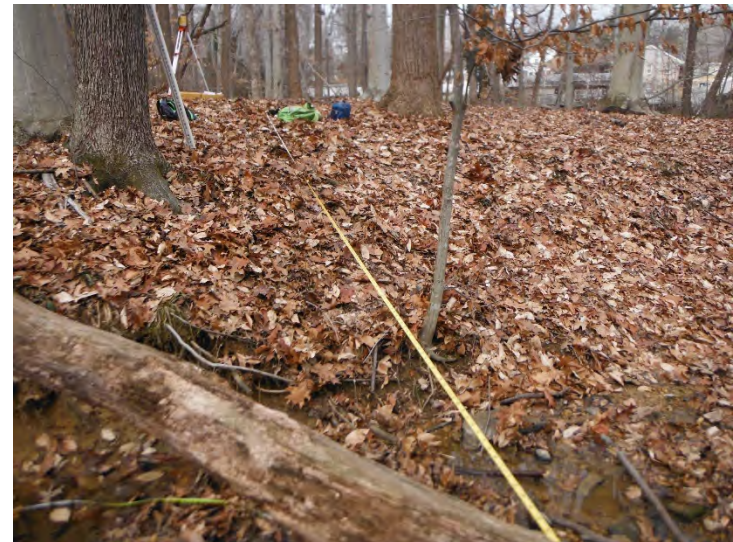
Reach 3 geomorphic cross section facing left bank.

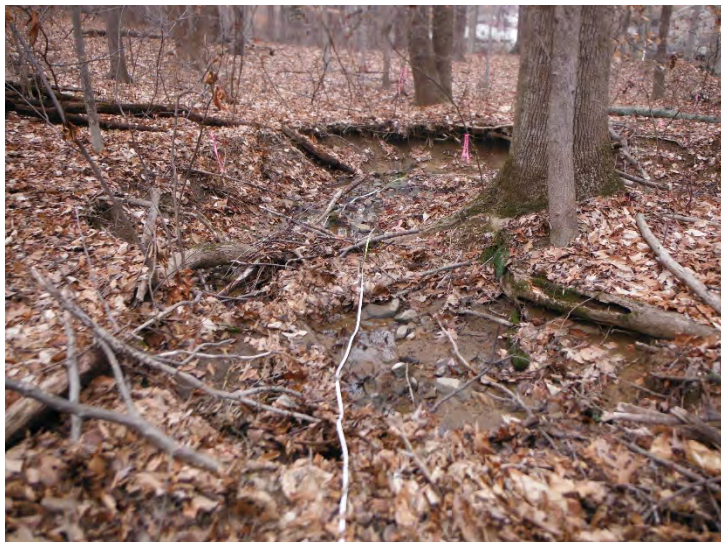
Facing downstream toward Reach 3 from just upstream of knick point.

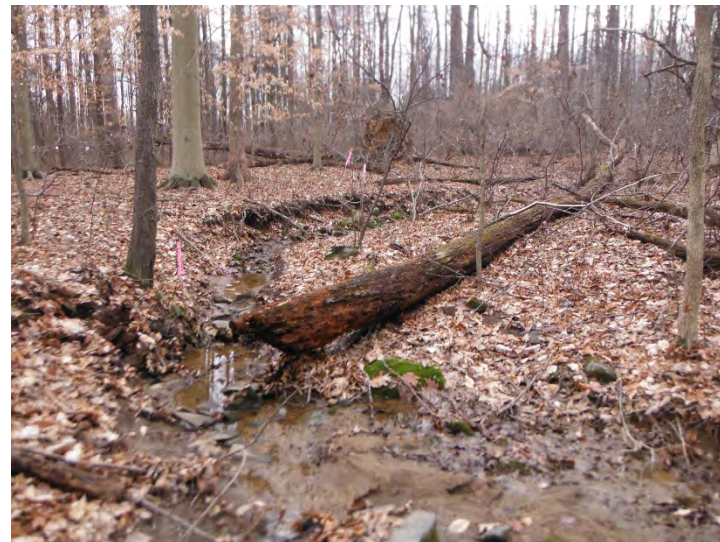
Facing upstream at the downstream end of the step pool reach where there is aggradation and deposition of fines.

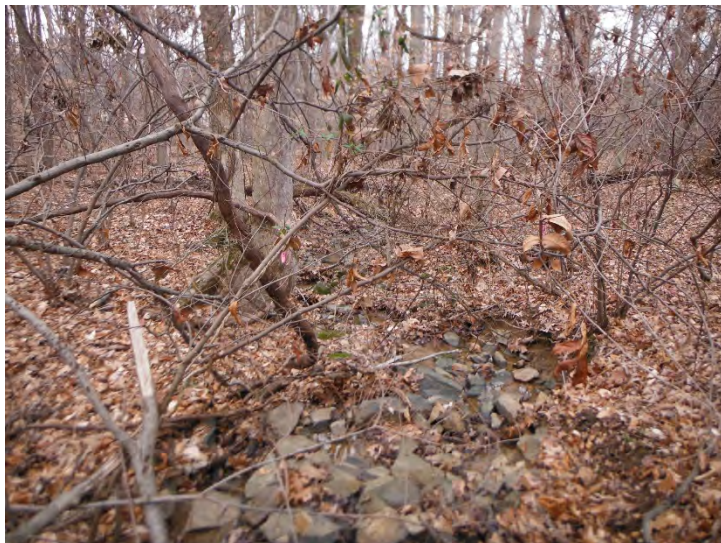
Facing upstream from middle of Reach 2 Sta. 3+80 (step pool reach)

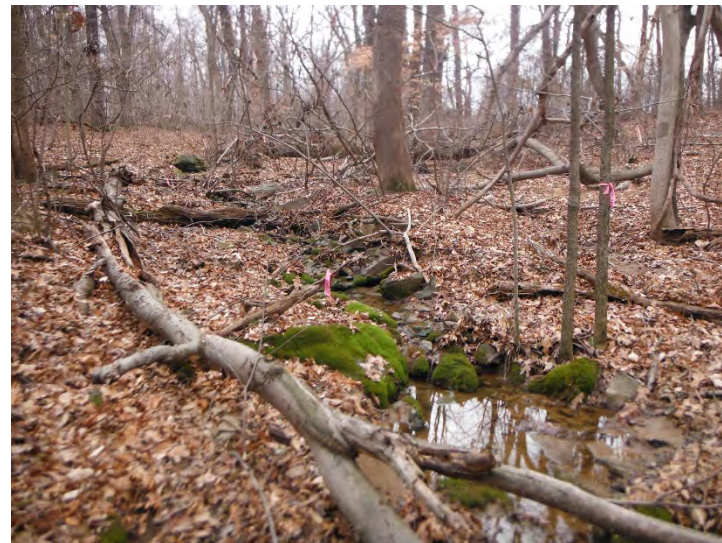
Facing downstream from middle of Reach 2 Sta. 3+80 (step pool reach).
Optimal habitat.

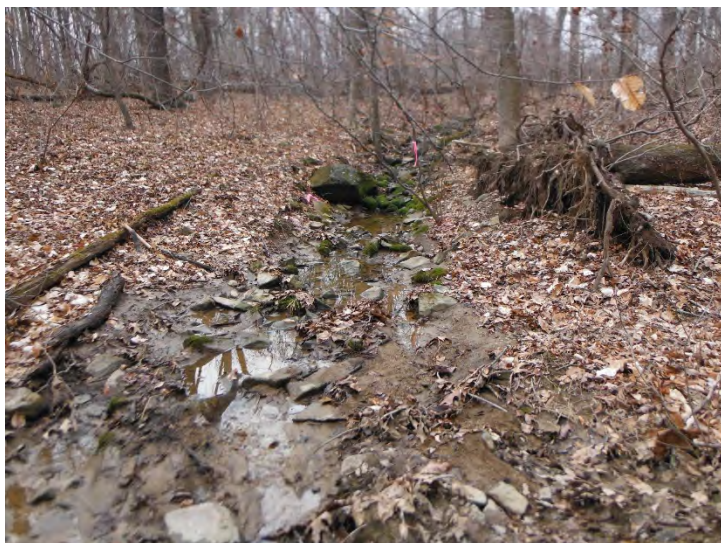
Facing upstream from downstream end of step pool surveyed
reference reach (Sta. 3+00)

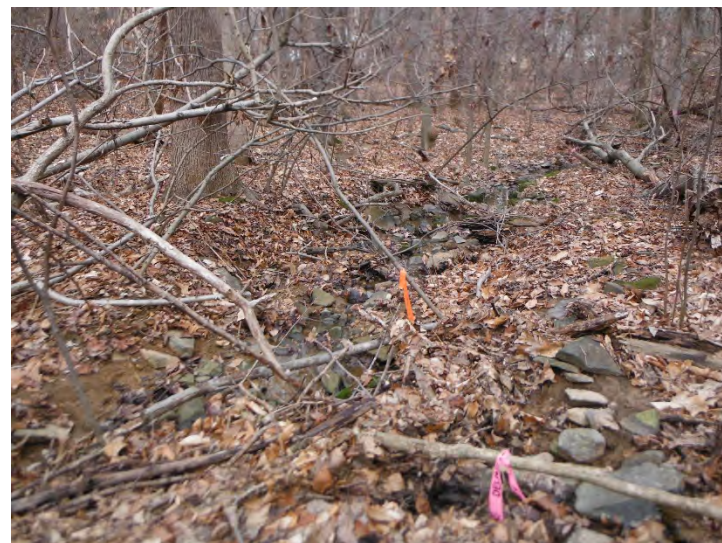
Facing downstream from downstream end of step pool surveyed
reference reach (Sta. 3+00)

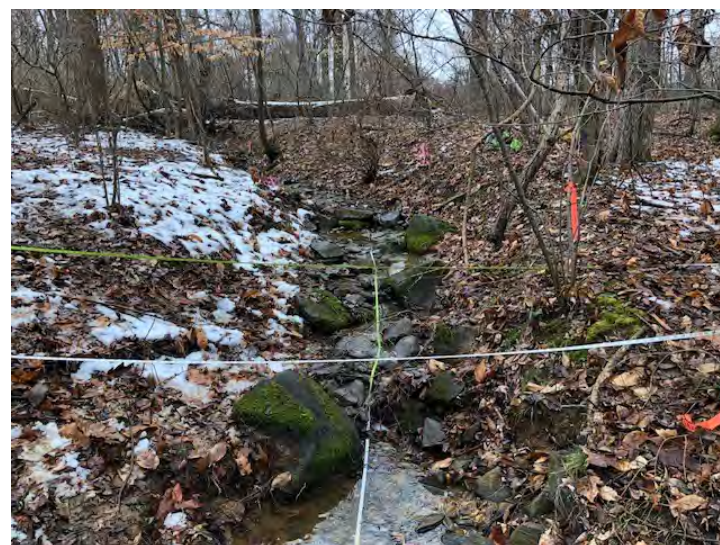
Facing upstream at step and pool geomorphic cross sections.

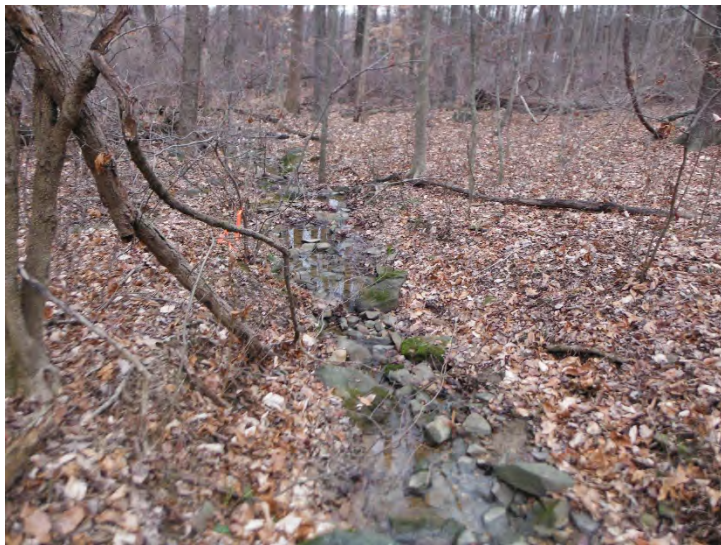
Facing downstream from upstream end of step pool surveyed reference reach (Sta. 2+10)

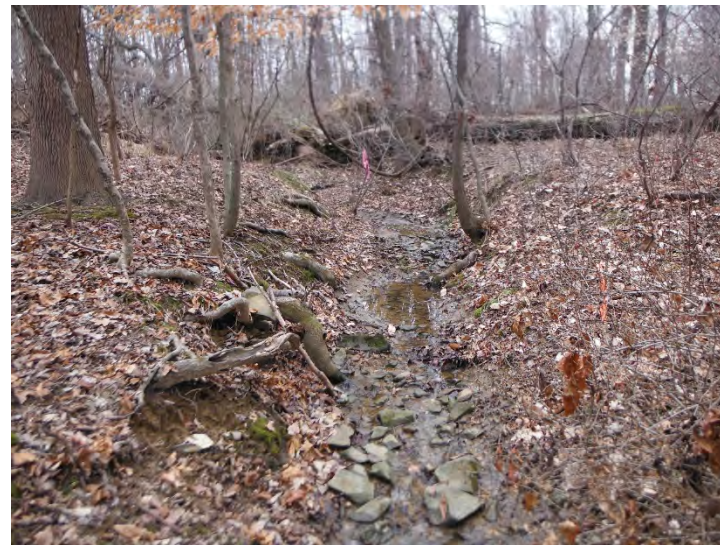
Facing downstream from upstream end of step pool surveyed reference reach (Sta. 2+10)

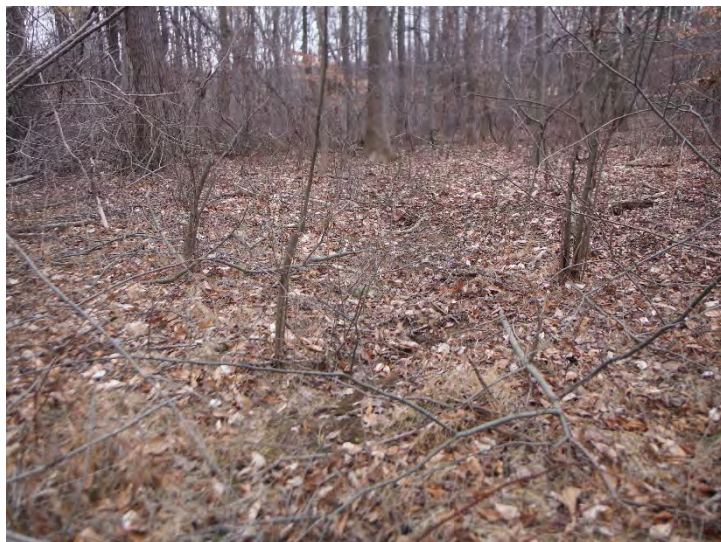
Facing downstream at side channel on right (not hydraulically connected to tributary, source not overserved)

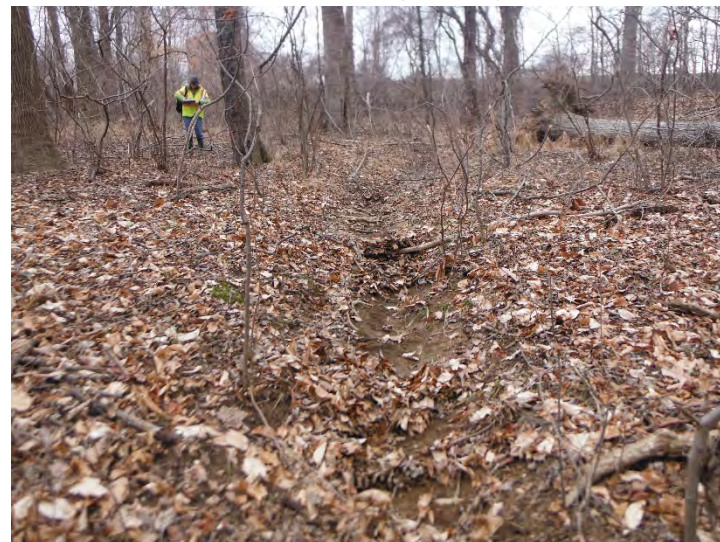
Facing upstream at the side channel that enters from the right near Sta. 2+10 in the middle of the surveyed Reach 2 reference reach.

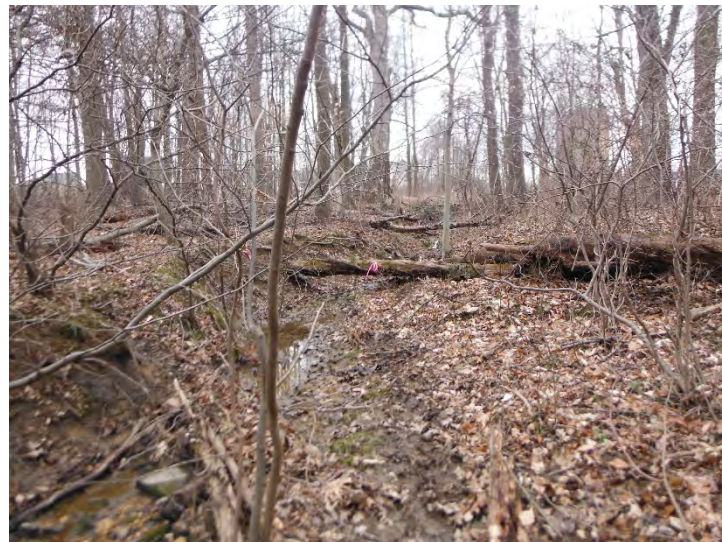
Facing upstream at typical Reach 1, just upstream of the debris jam / knick point (~Sta. 2+00).

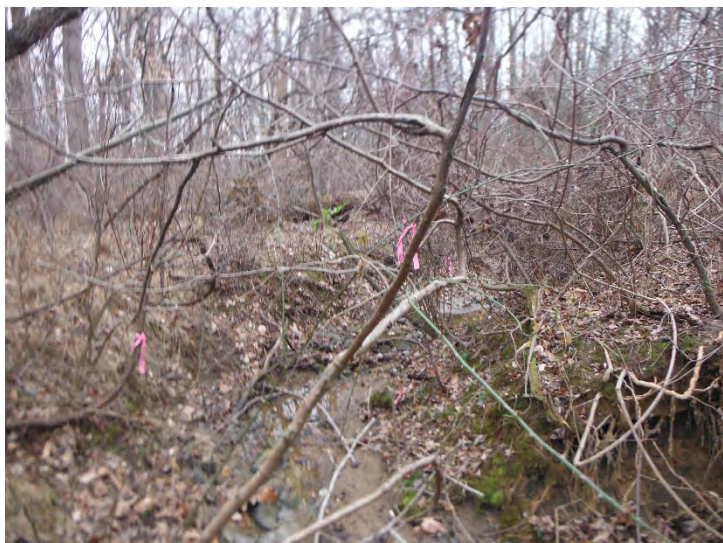
Facing downstream at typical Reach 1 from Sta. 2+00

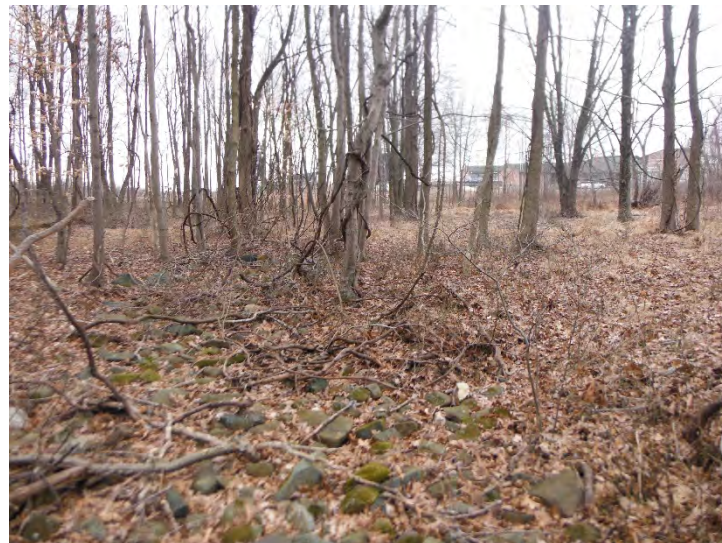
Facing southeast at riprap stabilization toward stormwater pond (does not discharge into study area).

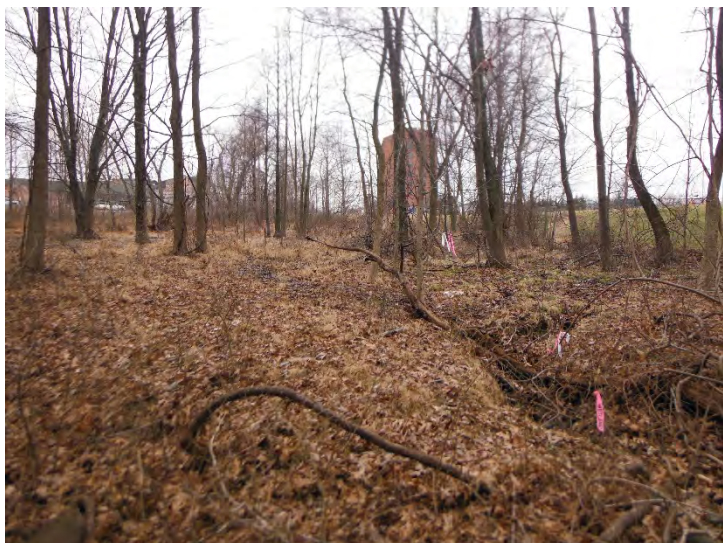
Facing west at existing swale at upstream end of study reach.

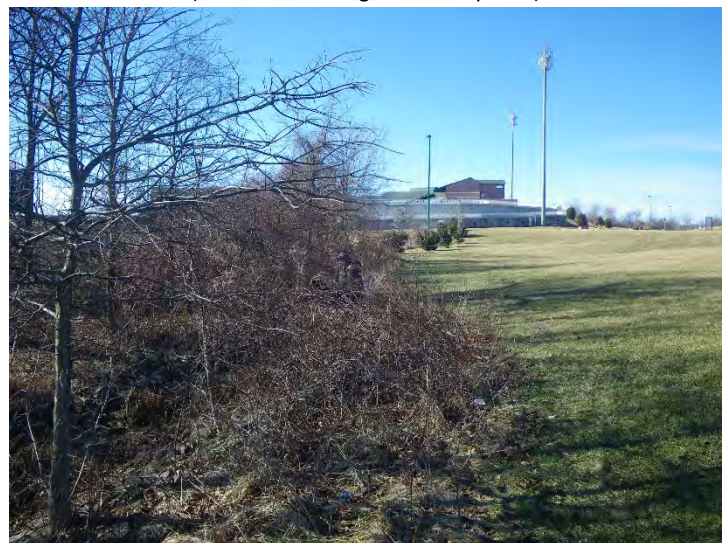
Facing upstream toward stormdrain pipe from Ripken Stadium.

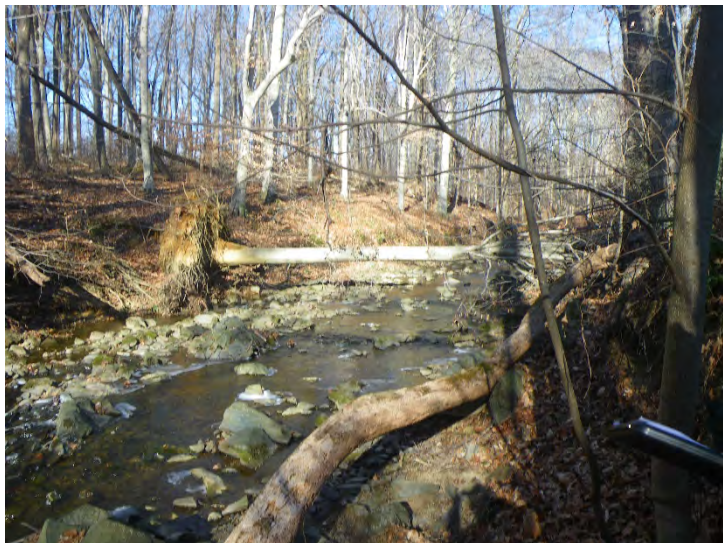
Facing upstream at upstream end of the study reach (~Sta. 10+00)

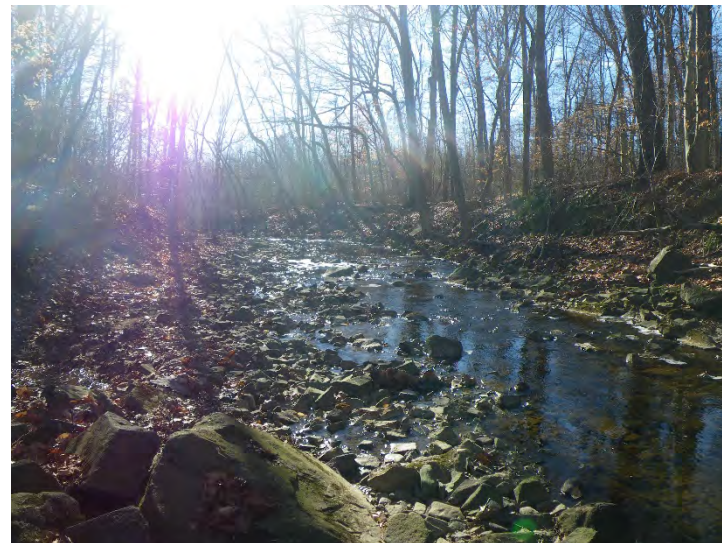
Facing downstream from near stormdrain outfall.

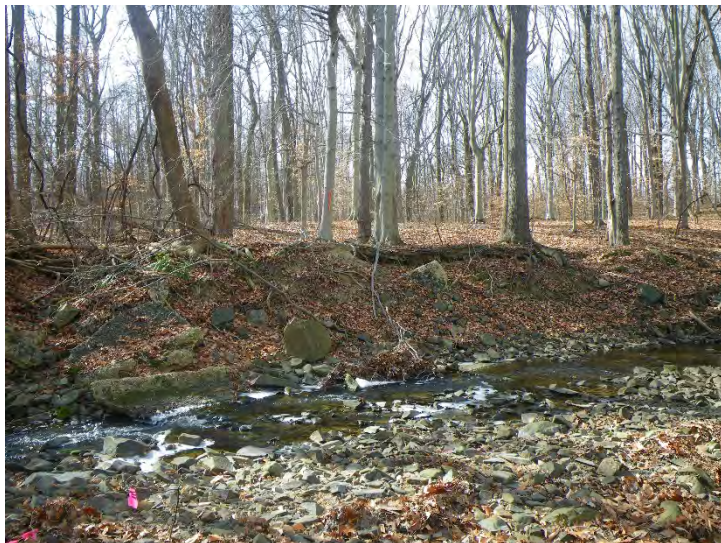
Facing right bank at cross section Sta. 12+03

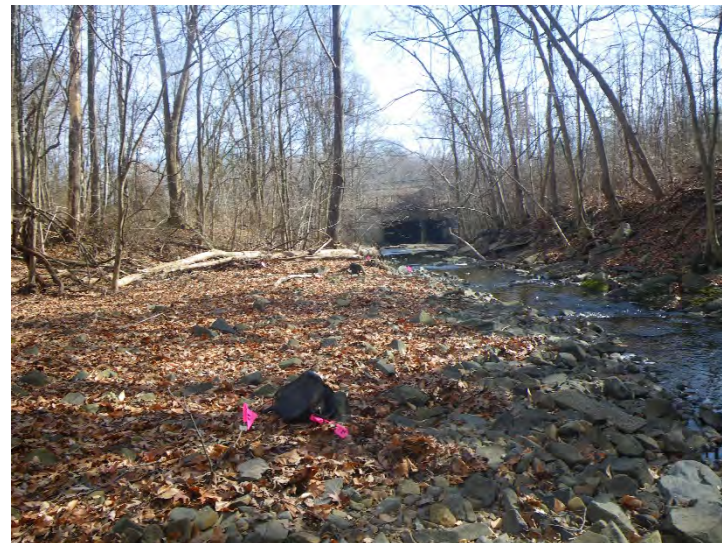
Facing downstream at cross section Sta. 12+03 (note flagged bankfull stage along point bar)

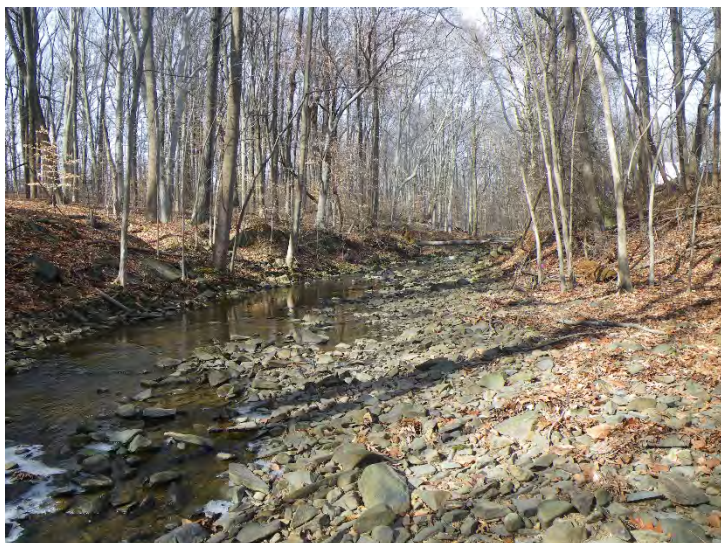
Facing upstream at cross section Sta. 12+03

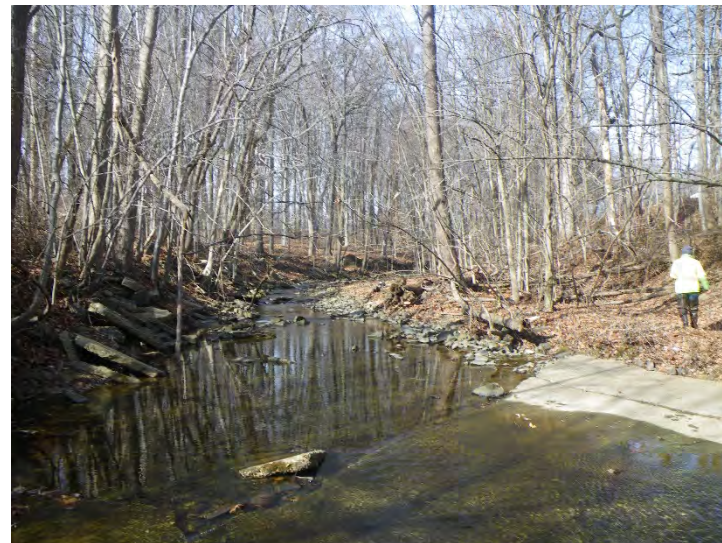
Facing upstream from Sta. 13+90 (proposed location of W-Weir invert)

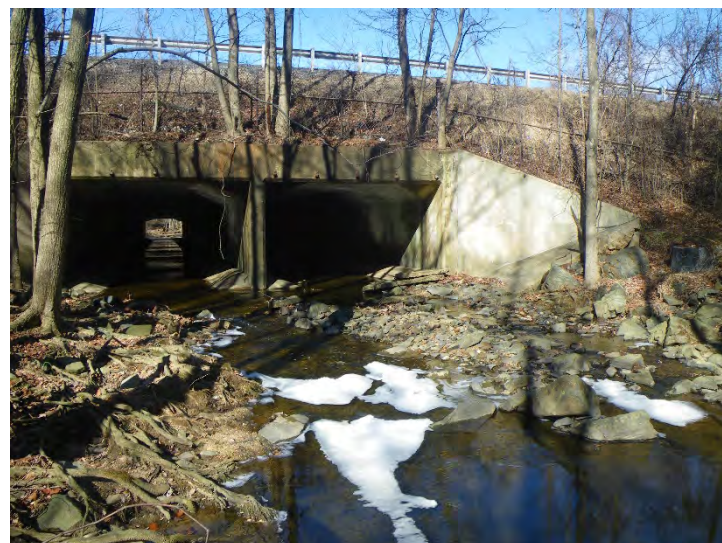
Facing upstream at the downstream face of the I-95 culvert (downstream of I-95), no fish blockages observed.

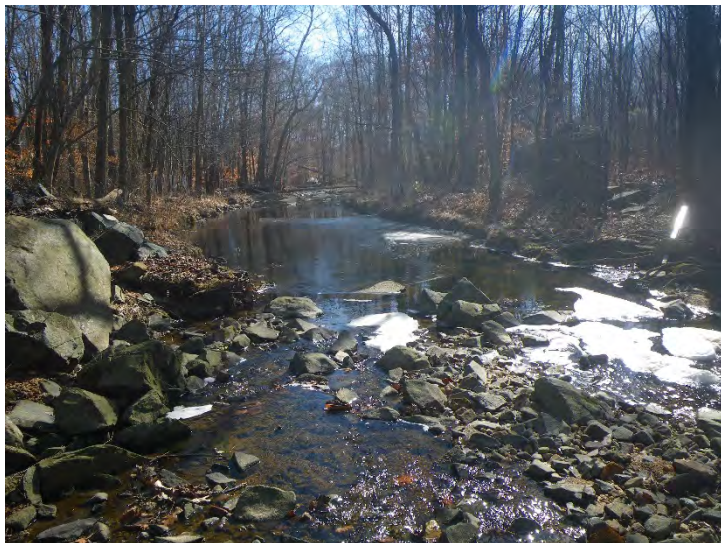
Facing downstream from I-95 culvert.
