Carsins Runs I-95 Section 200 Stream Mitigation

PS&E Design Report

Prepared for
MDTA

Carsins Run Stream Mitigation Existing Conditions Site Photographs

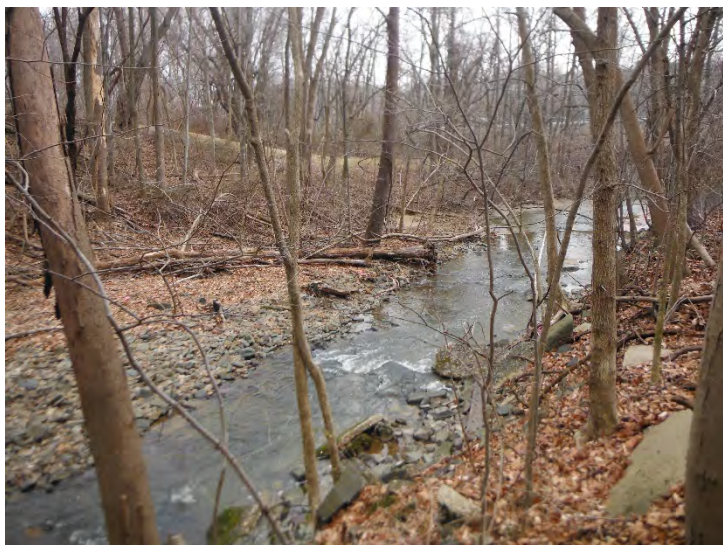
Facing downstream at mainstem from northwest tributary fork.

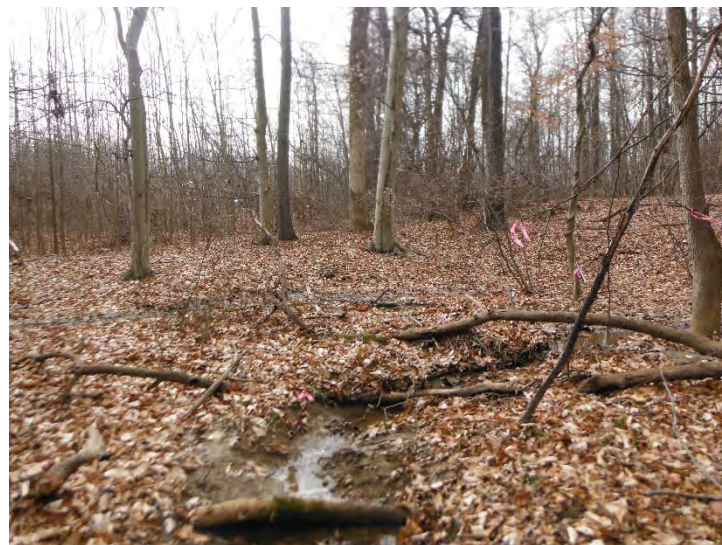
Facing upstream at the fork in the tributary.

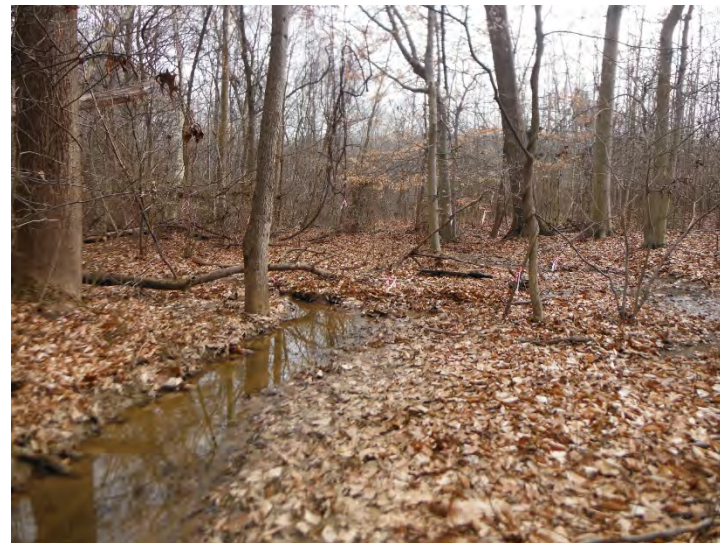
Facing downstream from tributary fork (~Sta. 8+50).

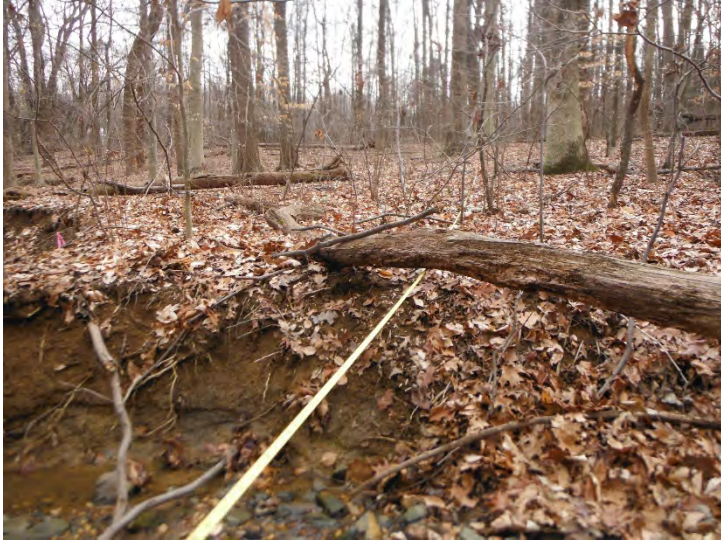
Reach 3 geomorphic cross section facing right bank.

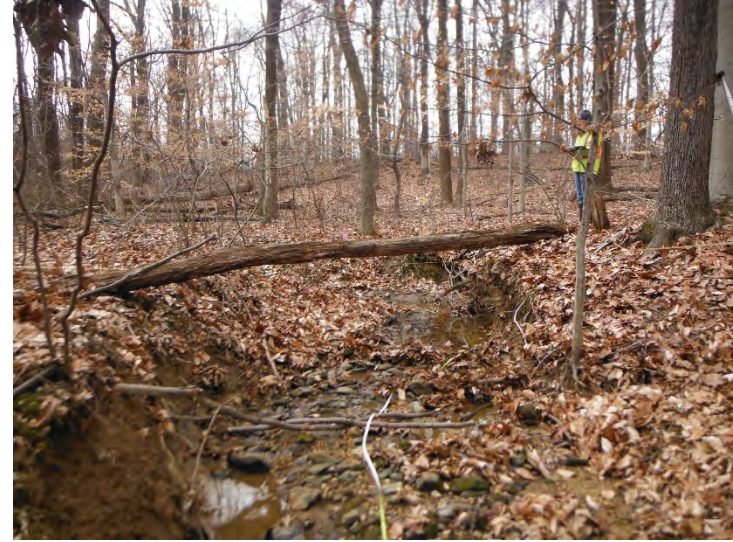
Reach 3 geomorphic cross section facing upstream.

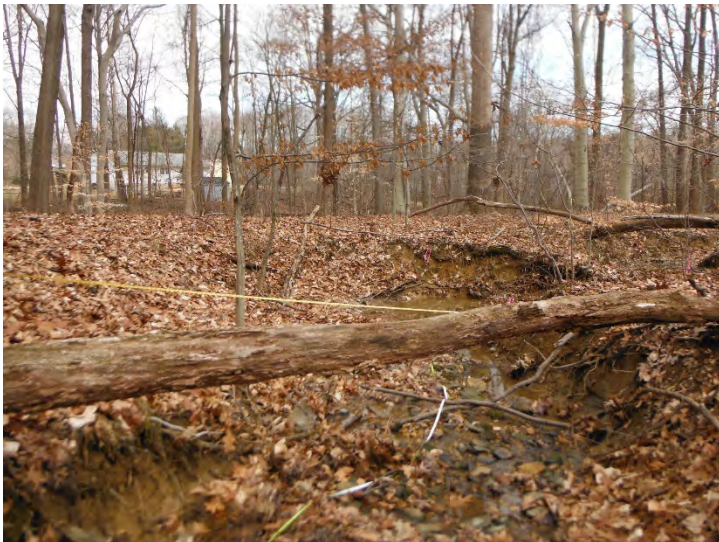
Reach 3 geomorphic cross section facing downstream.

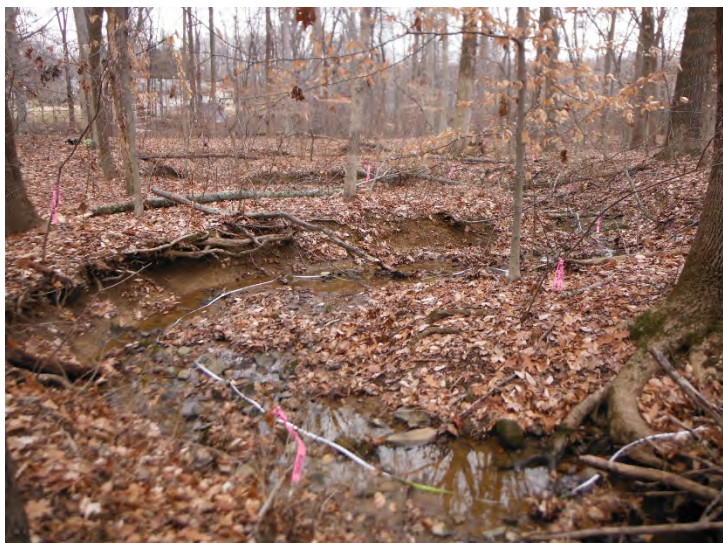
Facing downstream from just downstream of 2 foot knick point (Sta. 5+50).

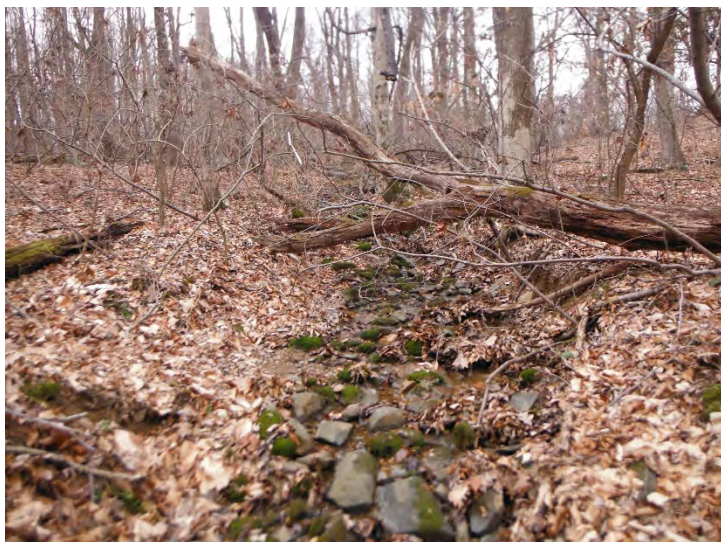
Facing upstream into Reach 2b (minor bank erosion)

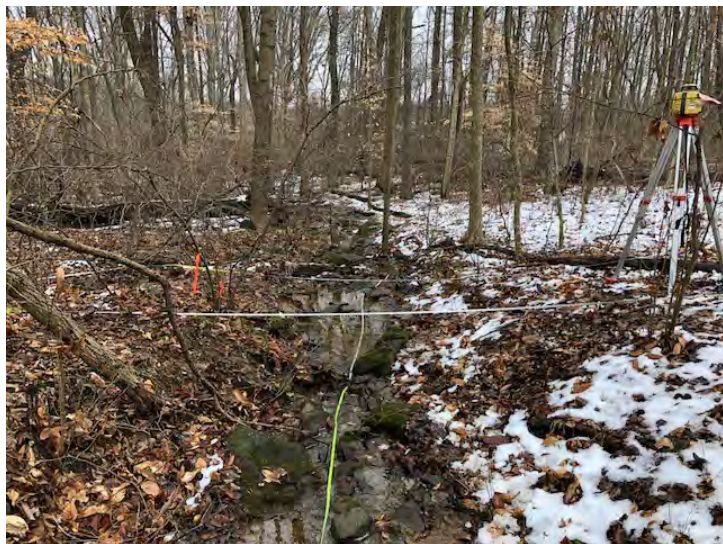
Facing downstream at step and pool geomorphic cross sections.

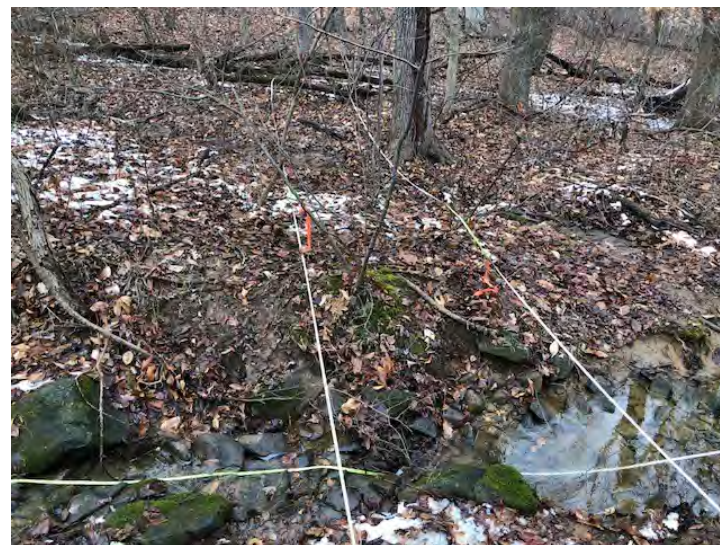
Facing the left bank at step and pool geomorphic cross sections.

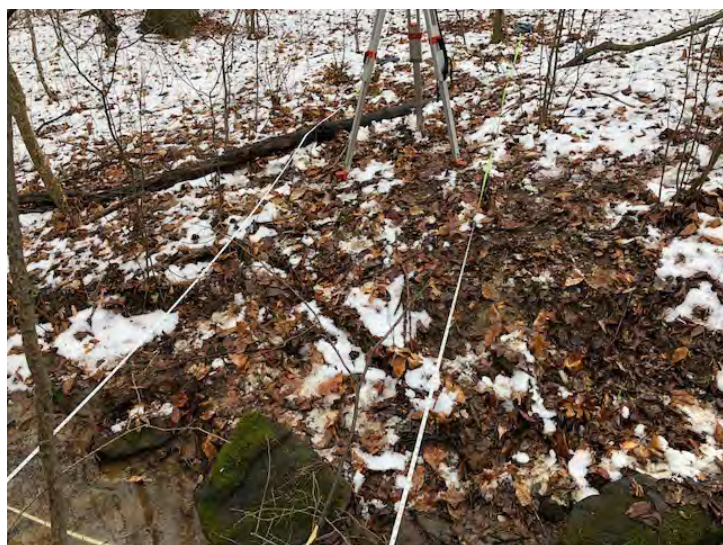
Facing the right bank at step and pool geomorphic cross sections.

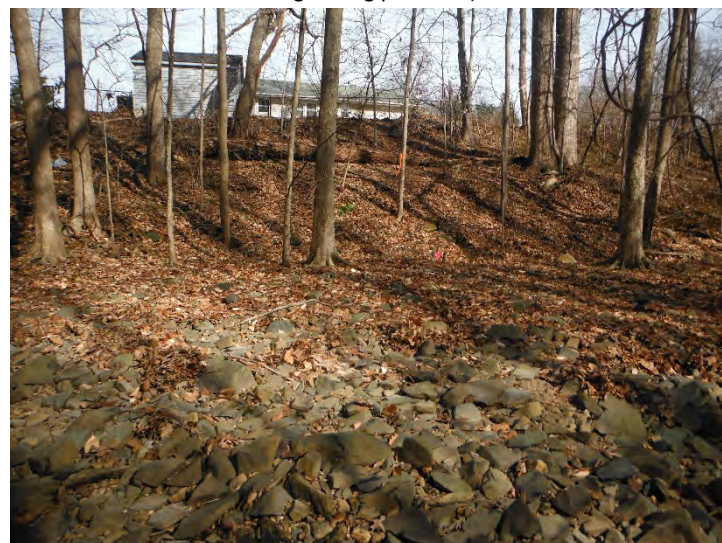
Facing left bank cross section Sta. 12+03
